BRIDGEHAVEN MARINA CONDITION ASSESSMENT

April 14, 2017

Draft Technical Memorandum Bridgehaven Marina Condition Assessment

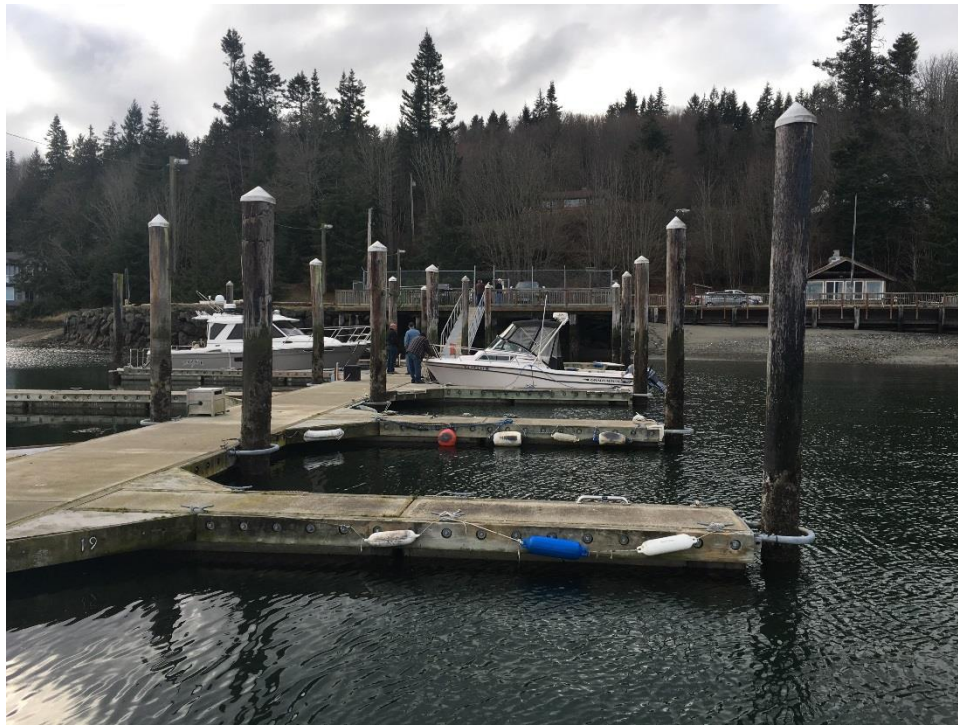
Photo #1

Moorage floats in good condition with some concrete surface cracks.

- Short Term
 - Concrete Surface Crack Sealing. Floats should be inspected annually for surface cracks and sealing conducted to prevent further deterioration of concrete and reinforcing steel from saltwater and freeze-thaw. An epoxy or grout type sealant should be applied in accordance with the manufacturer's recommendations. Consultation with Bellingham Marine Industries to obtain more detailed recommendations for maintenance work should be conducted and incorporated into the annual inspection and maintenance plan.

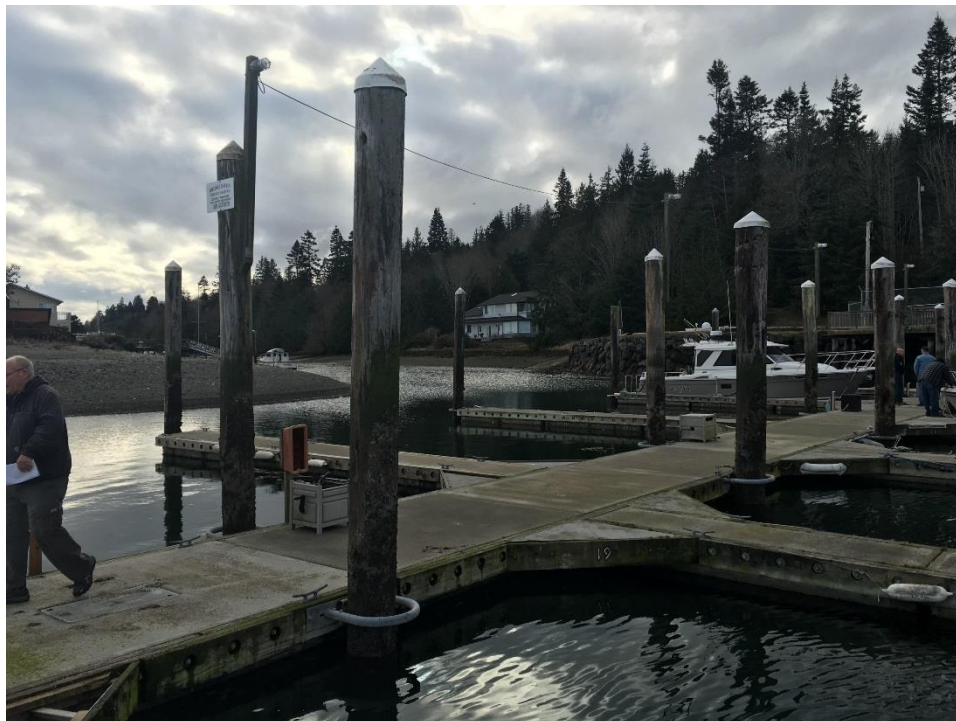
Photo #2

- Condition Assessment.
 - Timber piles were observed to have typical type and level of deterioration given the age and environment they are exposed to. Three piles were observed to have advanced or severe deterioration and the remainder of piles observed to have moderate deterioration (varying levels of interior untreated core loss but outer shell intact). Approximately half of the piles exhibited large deflection under small lateral force and the remaining half were observed to be relatively firm under the same lateral force. Piles exhibiting large deflection will have reduced lateral capacity due to insufficient embedment depth.

Moorage float piles with typical deterioration, multiple showing advanced deterioration.

- Recommendations:
 - Replacement of the deteriorated timber piles with steel pile would make sense at some point in the next 3 to 10 years. It would be recommended to select the piles with highest deterioration or lowest lateral capacity first but also ensure the pile replacement is spread out across the marina to get maximum benefit. Piles hoops may require adjustment to fit the new steel pile. It should be planned to replace up to five piles in the next three to five years and another 10 piles in years 5 to 10-year timeframe. A large number of piles could be replaced in the short term to take advantage of mobilization efficiencies.

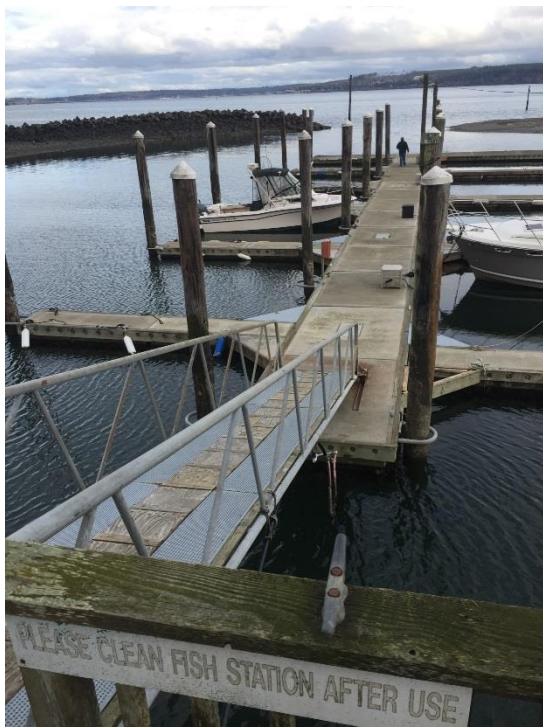
Photo #3

- Condition Assessment:
 - The gangway structure appears to be in average to good condition. The short length results in very steep slope at low water. The steep slope combined with the timber surface does not provide a desired level of user safety during access to the floats during low tide levels.

Gangway in good condition, longer gangway recommended in lieu of overlook structure rehabilitation.

- Recommendations:
 - Although the gangway does not require immediate replacement, the installation of a new longer gangway could assist in reducing costs for the maintenance of the overlook structure. Installation of a new 60 ft length gangway could provide improved user access at lower tide levels (flatter slope) and eliminate the need for accessing the gangway across the overlook structure thereby allowing the structure to be abandoned or removed. If the gangway is not replaced, consideration for replacement of the surface material with a grip strut galvanized aggressive surface grating is recommended to improve user safety.

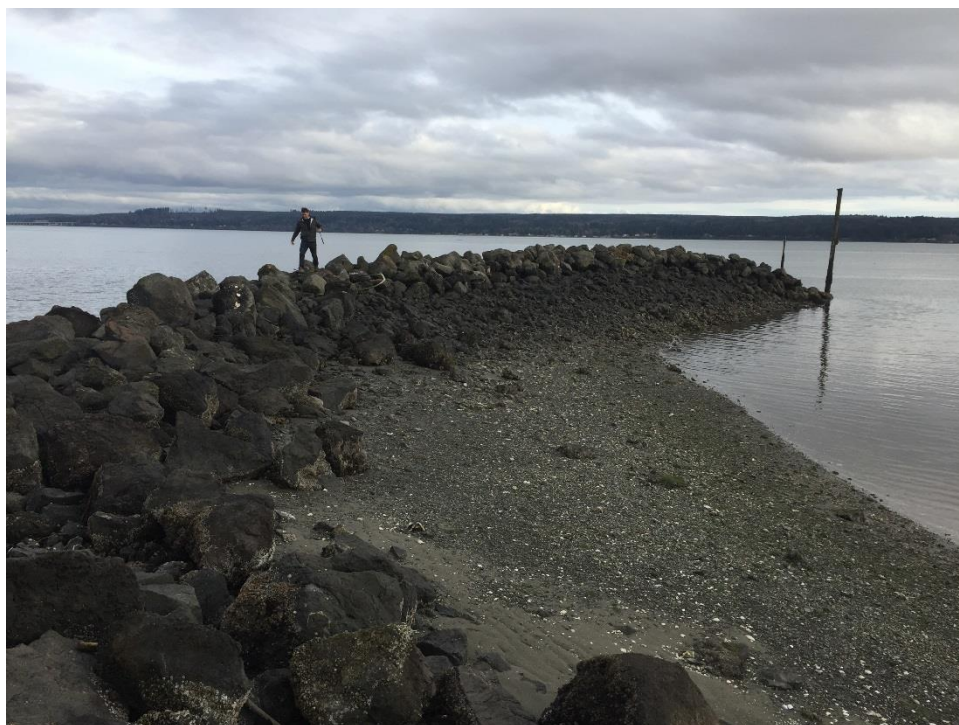
Photo #4

- Condition Assessment.
 - General. The breakwater structure was determined to be in an advanced state of deterioration including outer armor stone layer and loss of crest elevation. These elements are the two most important factors for breakwater performance and survivability during large storms. Rubblemound structures typically have a service life of 35 to 50 years for the type and quality of stone used. The breakwater armor stone is near or at the end of its service life.

- Crest Elevation. The lowering of breakwater crest elevation is of concern for the following reasons: 1) Accelerated deterioration of the breakwater can be expected (going forward) based on the current loss of armor rock on the crest and exposure of smaller and less stable core rock; 2) Greater wave energy penetration into the boat basin which will affect the marina floats (more motion putting stress on joints and tri-braces and more wave splash thereby increasing corrosion and maintenance of float steel, concrete and timber elements); and 3) Greater wave energy penetration into inner boat basin areas causing additional erosion along the toe and undermining of the bulkhead; 4) Deterioration of breakwater crest elevation can result in changes to the shoreline (erosion) along the north beach.

Detached breakwater with deteriorated crest needing rehabilitation.

- Recommendations:
 - Breakwater Rehabilitation. Rehabilitate the full length of the breakwater crest and the outer exposed slope. Total estimated quantity is approximately 1,500 to 2,000 tons. Reuse onsite materials on the backside of breakwater structure and as base material for the new armor stone. Rehabilitation would include the entire front slope and crest of the structure with a 1-stone layer of properly sized and quality material armor rock.

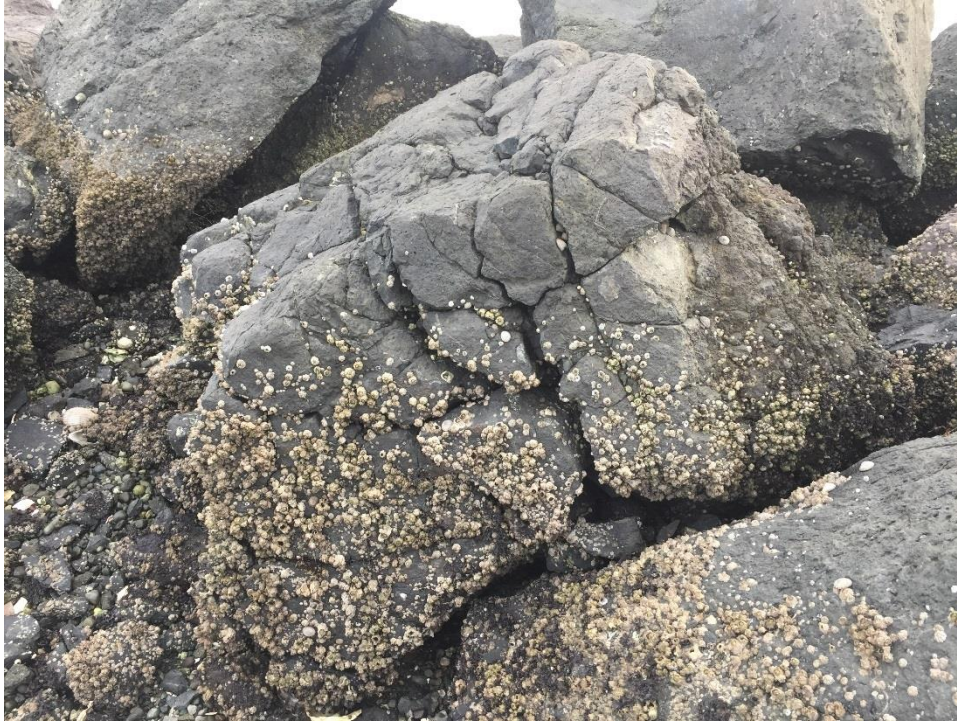
Photo #5

- Armor Stone. Armor stone was observed to be highly deteriorated and in an advanced state of degradation. The stone was also observed to be highly fractured resulting in breakdown into smaller, less stable pieces. The smaller armor stone pieces become mobilized by wave action during storms resulting in additional loss of crest elevation and exposure of inner layer of less stable, smaller core stone.

Fracturing of
breakwater
stone.

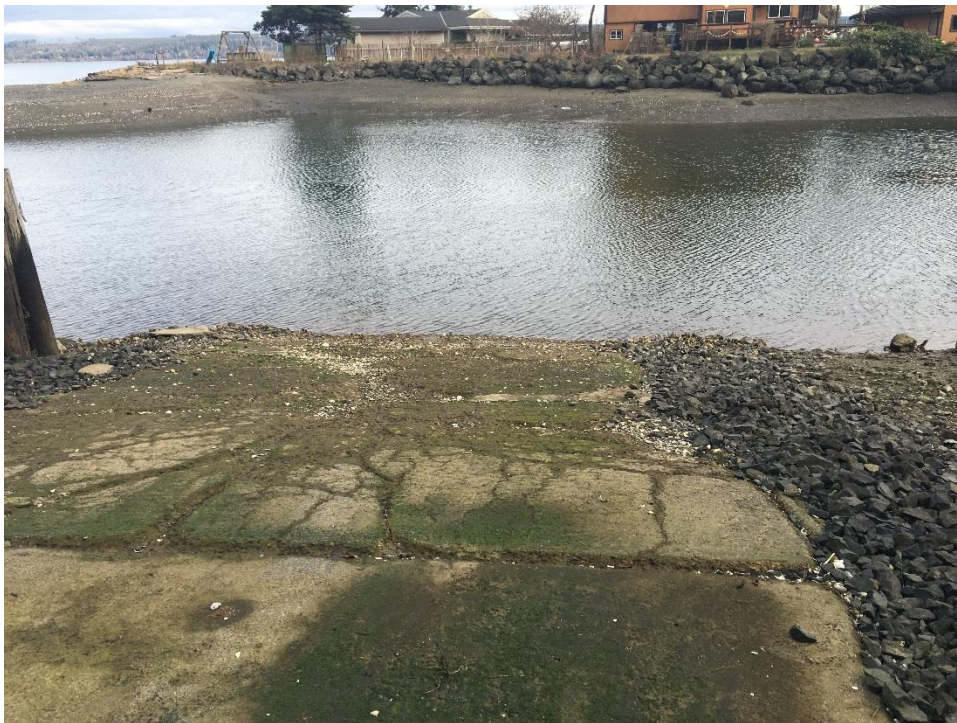
Photo #6

- Condition Assessment: The concrete ramp surface is highly deteriorated exhibiting cracking, spalling and high surface wear (exposure of aggregates). Concrete surface patching within areas of large spalling and voids have been conducted in recent years. The ramp is aligned on a curved alignment which is not an ideal condition but is required given the site’s geometric constraints. The ground located adjacent to the boat ramp is uneven and not a uniform slope matching the concrete ramp surface.

Deteriorated
concrete boat
ramp with
cracks, spalling,
and surface
wear.

- Recommendations:
 - Ramp Concrete Slab.
 - Short Term Repairs. Cleaning and pressure washing. Filling localized areas with concrete repair materials and sealing cracks and joints are also likely be needed.

- Intermediate Term Rehabilitation. Longer lasting concrete repairs would include saw cutting out the highly-fractured and spalled areas, repair and compacting of gravel base, installation of dowel bars around the perimeter of concrete sawcut line and installation of new concrete slab.

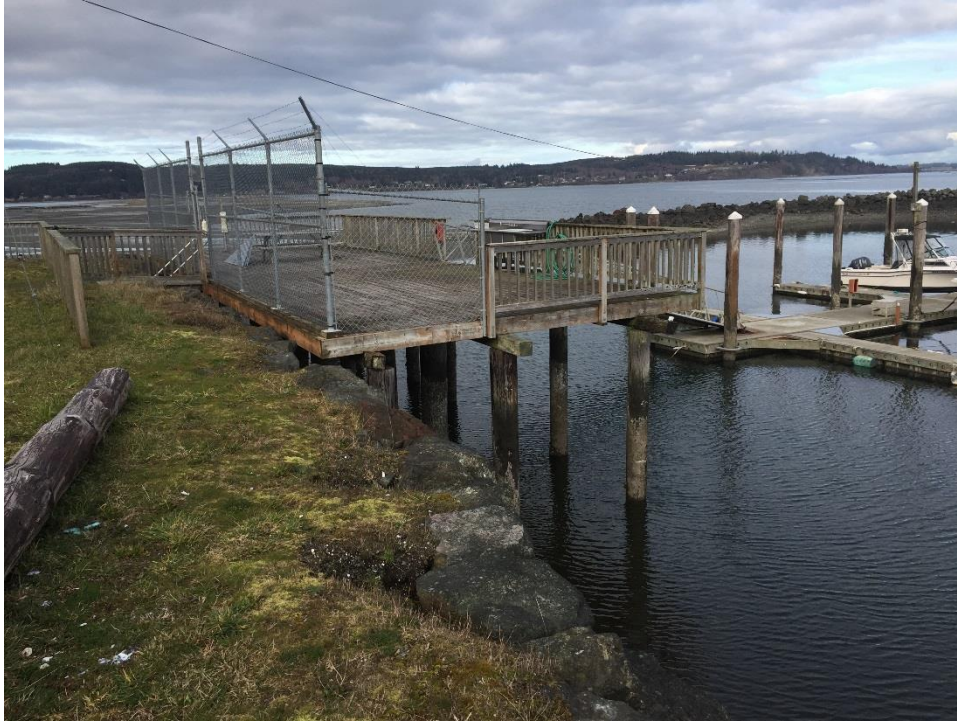
Photo #7

Overlook structure requiring inspection and monitoring, may need rehabilitation or removal.

- Monitoring and Inspection. Until repairs are made, monitoring and inspection of these elements should be conducted on a routine basis.
- Use. Continued use should be limited to light duty pedestrian use and large crowds should not be allowed to congregate on the overlook structure (in particular, those areas pointed out to be problematic). Warning signs to prevent large gatherings and no large loads should be considered.

- Rehabilitation. If it is desired to preserve the overlook structure as a usable facility for the marina, rehabilitation will be needed. Rehabilitation will include replacement of pile (deteriorated pile near the gangway connection), removal of misaligned stringers, adjustment of pile caps, installation of a new stringer and replacement of decking boards. It would make the most sense to conduct a comprehensive rehabilitation of the remaining overlook structure that is needed for use and then demolish the remaining elements that are not needed. A major rehabilitation should be planned for some time in the next 5 years.

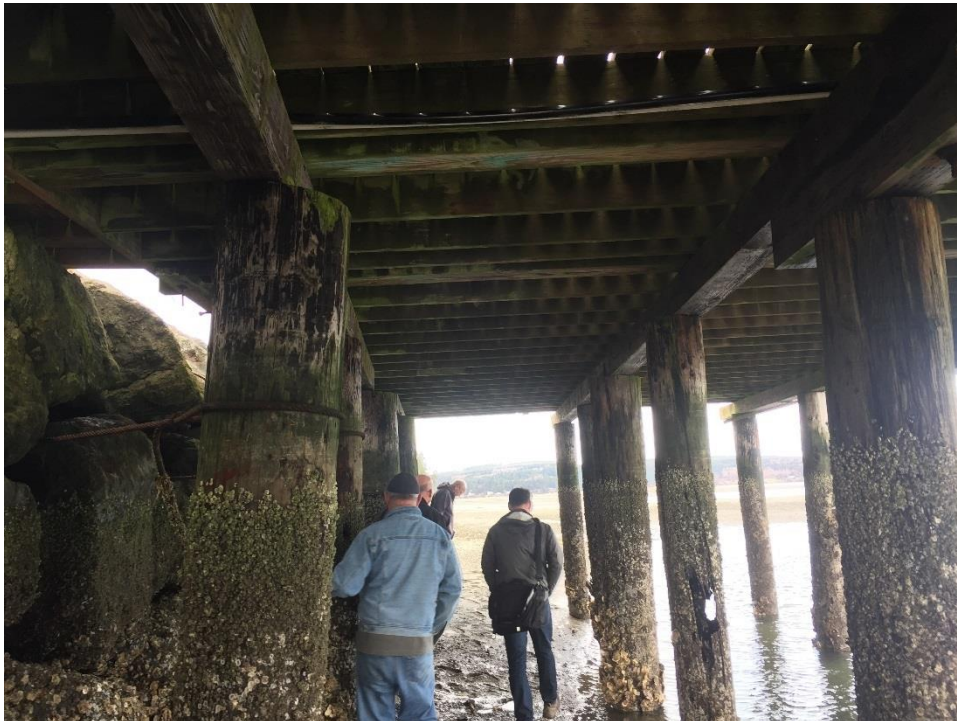
Photo #8

- Piles. Piles were observed to have typical type and level of deterioration for the type, age, and environment they are exposed to. Two piles were observed to have advanced or severe deterioration and the remainder of piles observed to have moderate deterioration (varying levels of interior untreated core loss but outer shell intact).

- Capacity. The vertical capacity of the structure is reduced within the area of the highly deteriorated piles. One of these piles supports the decking loads within the area in front of the gangway connection. Structure capacity is further reduced by the misalignment of the stringer to pile cap connections. Lateral capacity of the structure appears to be low given the type of construction and condition of the members.

Underneath overlook structure showing pile deterioration and cap posting.

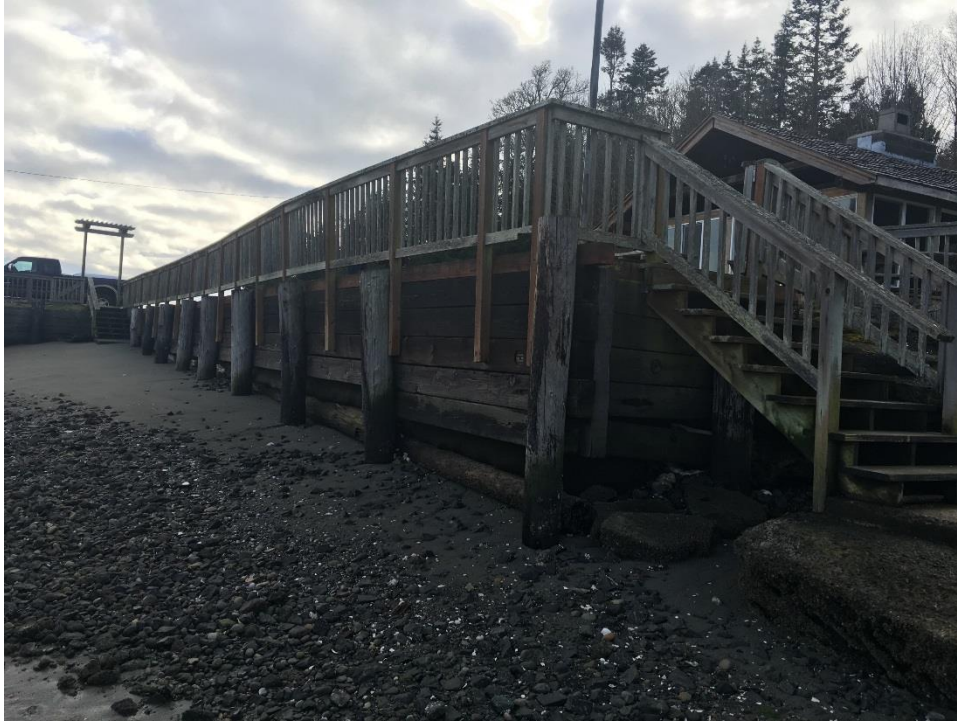
Photo #9

- Toe Scour. Scour was observed at the toe of the entire length of the north timber bulkhead, and in many areas, has progressed below the bottom of the timber lagging boards. The undermining of the bottom lagging boards is contributing to the loss of backfill materials and the formation of sink holes.

Timber bulkhead toe scour and undermining of lagging boards exposing backfill to erosion.

- Repairs (short to intermediate term). Install lagging boards on the waterward side of timber piles below the beach level and extending above the bottom of the existing lagging. Installation of geotextile fabric and backfill within the voids between the outer and inner lagging. Excavate sinkholes and backfill with granular rock fill. Seal up gaps in timber lagging. Install missing top lagging boards.

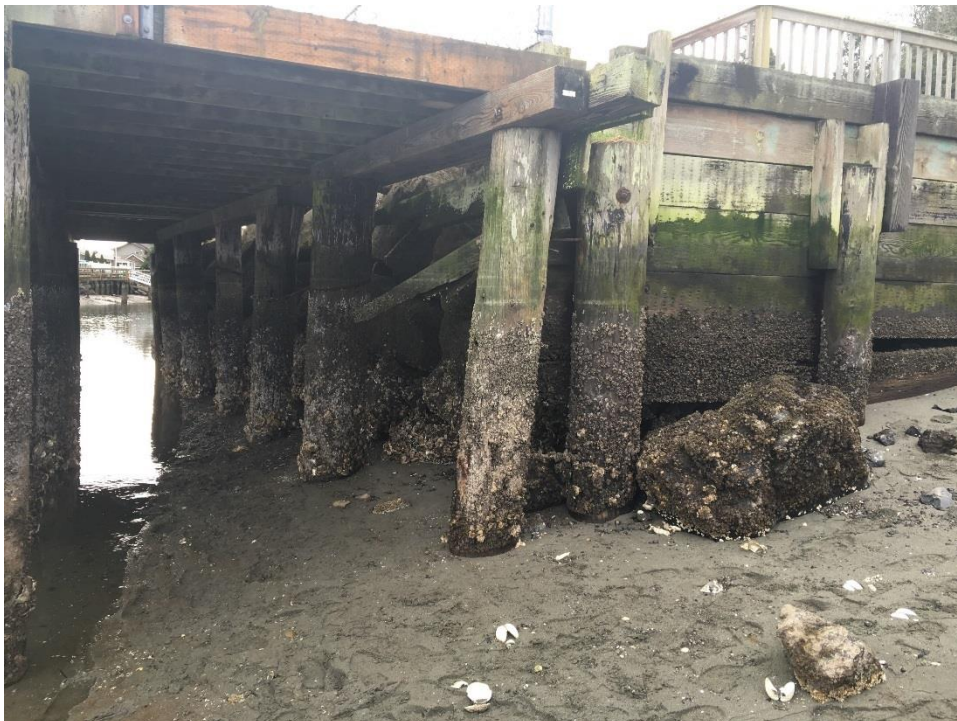
Photo #10

Timber bulkhead on side of overlook structure toe scour and loss of backfill.

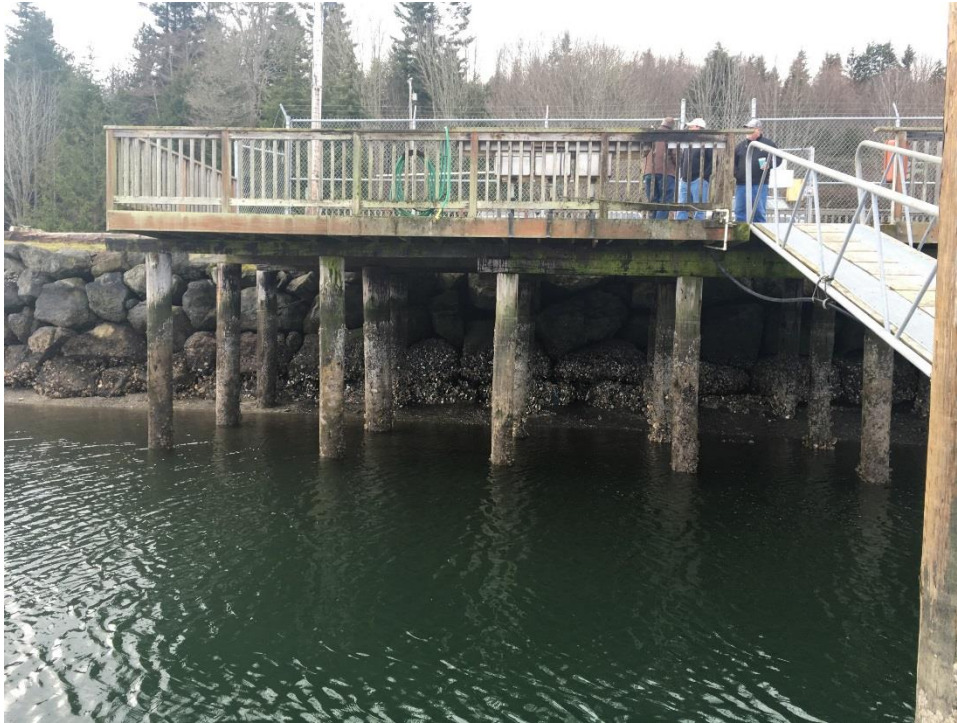
Photo #11

Stone bulkhead and overlook structure.

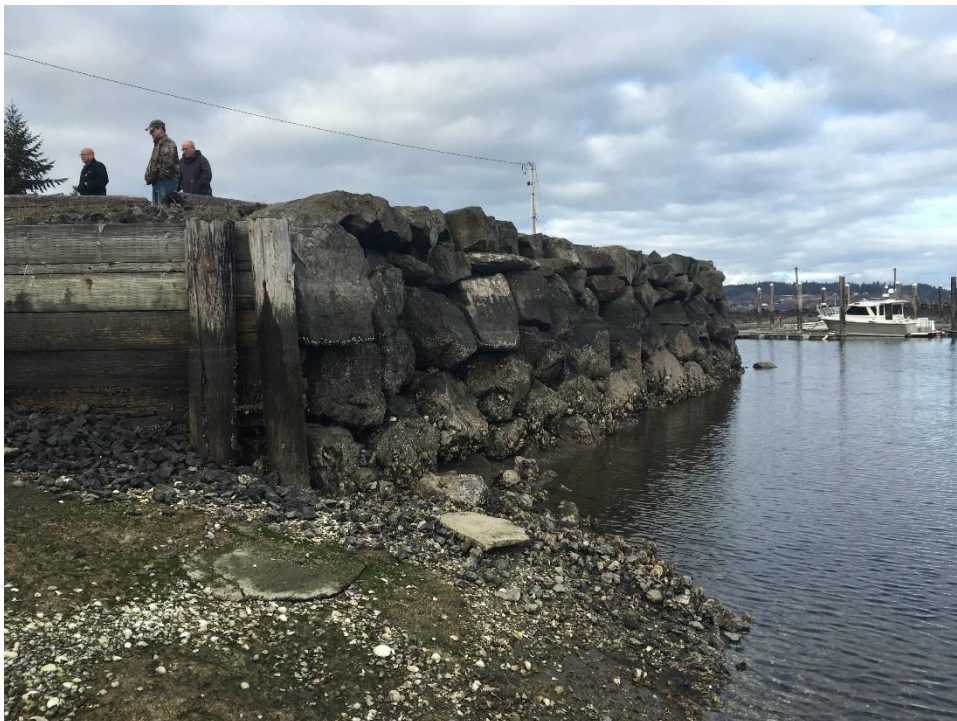
Photo #12

- Stone Bulkhead. Armor stones appear to be in good condition. A few sinkholes were noted. No serious stone material degradation or overall stability concerns observed. Stone bulkhead generally good condition.

Stone bulkhead looking from boat ramp.

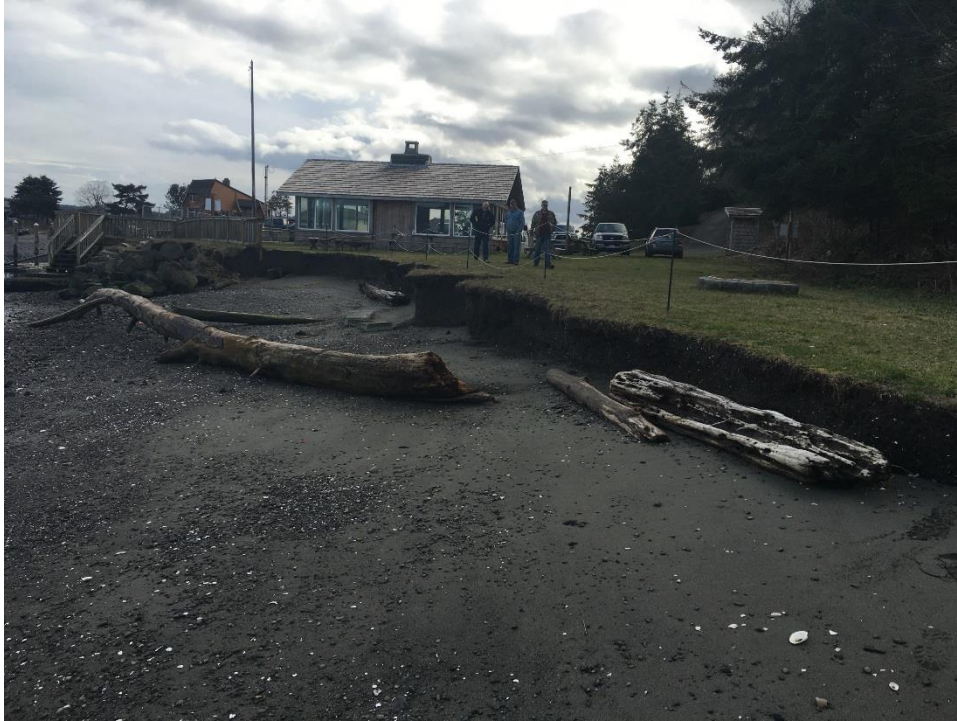
Photo #13

- Condition Assessment:
 - Scarp. Erosional scarp located immediately adjacent to the north bulkhead was measured to vary from 3 to 4.5 ft in height. Erosional scarp is composed of sand, gravel, silt, shell fill which was likely materials excavated/dredged during the original marina construction.

- Causes of Erosion. Primary cause of erosion is the original placement of dredged material within a historical intertidal zone. Installation of the breakwater assisted in providing some protection of the shoreline fill to reduce erosion but not entirely. Therefore, erosion of the shoreline is a natural process of the beach adjusting to its new equilibrium conditions. Continued and acceleration of erosion could be a result of the breakwater crest deterioration and loss of beach level offshore within the original spit footprint thereby allowing increasingly greater level of wave energy (and frequency of occurrence) to the shoreline area just north of the gazebo.

North beach
erosion.

- Recommendations:
 - Shore Protection Measures. Erosion protection measures will likely be needed if the upland facilities (gazebo, etc.) are intended to be protected from continued erosion. These measures could include the following:
